TUCURUI'S GENERATOR STEP-UP TRANSFORMER FAILURES DUE TO VERY-FAST TRANSIENTS IN GIS

J. F. de Lima F^o C. Machado Jr. W.S. Pinto
Centrais Elétricas do Norte do Brasil - ELETRONORTE
BR 70718-900 SCN Quadra 6 Conj. C Brasília DF-Brazil

J.C.Mendes R.A.Marcondes
ABB Asea Brown Boveri T&D
BR 07190-904 São Paulo , SP-Brazil

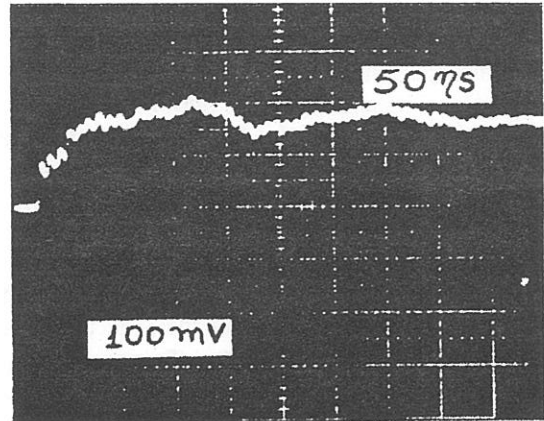
Figure 2 - Closing field record

Opening and closing operations in the Fig. 1 disconnect switch 4 were made and voltage measurement were registered at PMA (phase B SF₆/air bushing) and PMC (phase B unit disconnect switch). Fig. 2 shows test field results, Fig. 3 presents the configuration for simulations and Fig. 4 shows simulation results for Fig. 2.

A detailed comparison was performed between figure 2 and 4. The latter showed that the greatest overvoltage of 1.23pu happened 141ns after disconnect switch closing, with 4kV/ns rate of rise. The corresponding measured amplitudes were 150ns and 3kV/ns. After 300ns the overvoltages came at 1.18pu (simulation) and 1.19pu(field). The highest observed frequencies, corresponding to the smallest oscillatory amplitudes of Figures 2 and 4 remained around 160MHz (simulation) and 150MHz (field), highlighting the little precision on achieving it through field record.

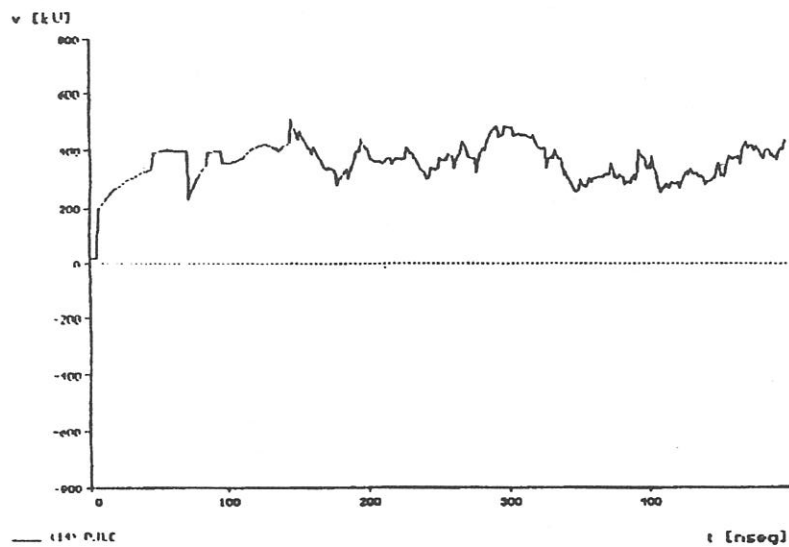
Figure 4 - Closing simulation

In Fig. 4 the simulation test was performed with 0,04 pu residual voltage and the closing time was changed so that the same 1.23 pu measured overvoltage could be achieved.

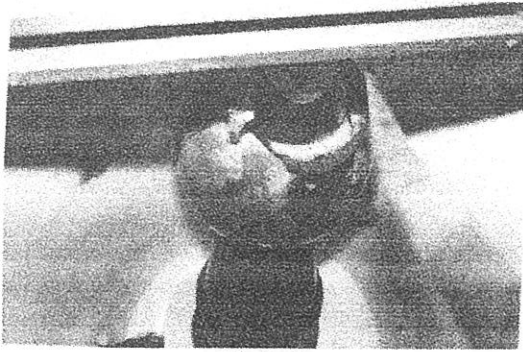
Photo 1

The second failure, involving also the transformer that was connected to the 2nd generator, occurred in June 1988, as showed in photos 1 an 2.

After failure of the second unit, the transformer manufacturer changed the insulation system of the inner HV bushing end shield on side wall turret. This change was extended to all units.

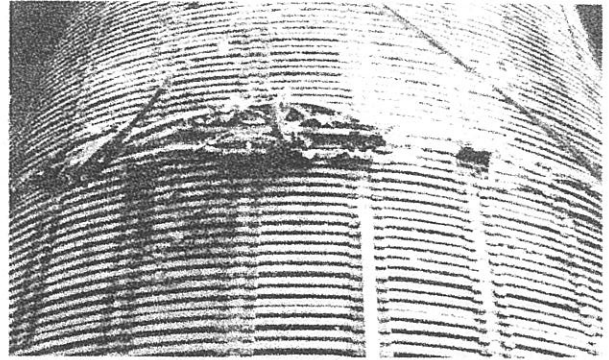
Photo 5

In a preliminary ELETRONORTE/ABB on site inspection, it was detected signals of electrical discharges on the HV winding of phase B, closest to the corresponding winding entry. However, due to limited access and damages, it was carried out a complete disassembly in order to investigate the failure extension. Windings were removed disk after disk, starting from HV and finishing at LV windings. This operation was documented with several photo (3 through 8). The main observations were:

- transformer tank rupture and deformation due to internal explosion associated to gas evolution;
- local rupture of bushing insulator which may give an indication of high mechanical stresses;
- mechanical rupture of one, out of two parallel winding conductors, in the connection between coil disk and HV winding terminal;
- several signals of electrical discharges on the winding conductors of the disk pairs located closest to the HV winding terminal. It was also observed rupture of conductors on crossovers and transpositions of the related coils;
- mechanical deformation of conductors in coils closest to the HV winding terminal;
- directed electrical discharge from HV to inner adjacent LV winding through the main duct insulation;

- rupture and signals of electrical discharges on LV winding conductors located approximately 120 mm below the HV winding radial central entry and
- in the 13.8 kV generator unit surge panel it was also found indication of a probable short-circuit to ground, namely: signals of electrical discharges from the surge arresters end terminals and surge capacitors (phase B) to the panel metallic side wall (grounded); signals of external electrical discharges on the ZnO blocks and internal short-circuit in the surge arresters and short-circuited capacitors.
