Overvoltage Protection Performance of the 110 kV Overhead Lines after the Line Surge Arresters Implementation

M. Mesić, I. Uglešić, B. Filipović-Grčić, S. Piliškić, M. Mijoč, B. Franc

Abstract-- The overview of the outages of 110 kV overhead lines has been given in this paper. Correlation of the relay protection tripping data and lightning location systems (LLS) data has shown the impact of the lightning on the operation reliability of the overhead line. The EMTP/ATP software has been used for simulation and analysis of power system performance with respect to lightning overvoltages in cases with and without line surge arresters. The input data for the simulation are data on lightning strokes which caused the relay tripping of the overhead line obtained from the relay protection system and LLS. Simulations have proved the relay protection system and LLS performance.

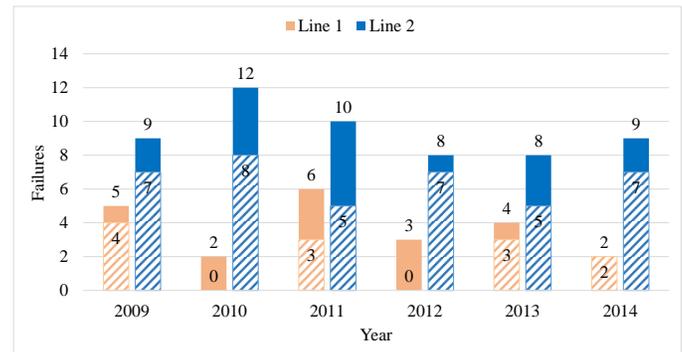
Fig. 1 shows the yearly distribution of total number of failures and those caused by the lightning on the observed overhead lines. The lengths of the overhead line sections are 5.929 km and 8.228 km for the overhead lines 1 and 2, respectively.

Fig. 1. Number of the total failures and failures caused by the lightning in period 2009-2014

It is important to emphasize that all of the failures due to the lightning in year 2014 occurred after LSA installation to the observed overhead lines. This fact might lead to the wrong conclusions regarding overvoltage protection performance, but the analysis of the lightning activities in the observed area within the next chapter has provided reasonable explanation.

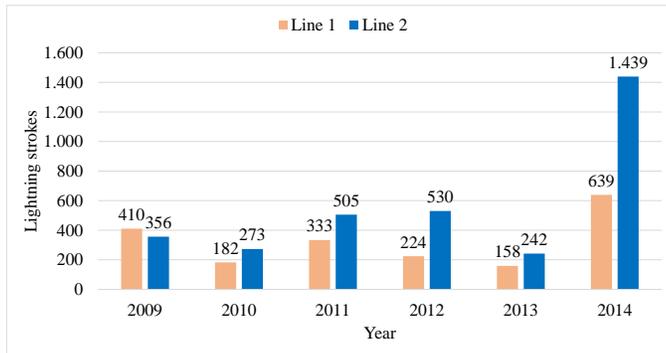
Fig. 2 represents the lightning stroke distribution registered by the LLS within the alarm zones around the observed overhead lines for the time period 2009-2014, while Fig. 3

Fig. 2. Number of the lightning strokes within the alarm zones (2009-2014)

Distributions of the lightning strokes represented on the Figs. 2 and 3 show that the unexpected high number of the failures after LSAs installation was probably caused by the extreme climatological conditions and increased lightning activity during the last six months of the year 2014.

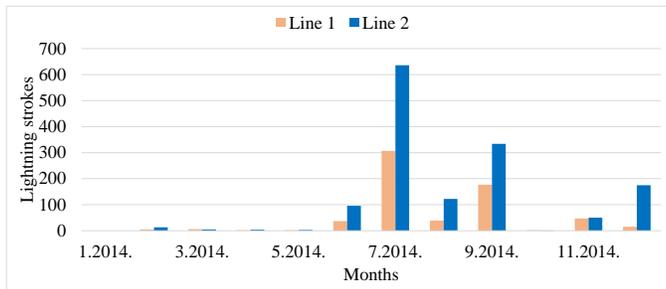
shows the lightning stroke distribution within the alarm zones for the year 2014.

Fig. 3. Number of the lightning strokes within the alarm (2014)

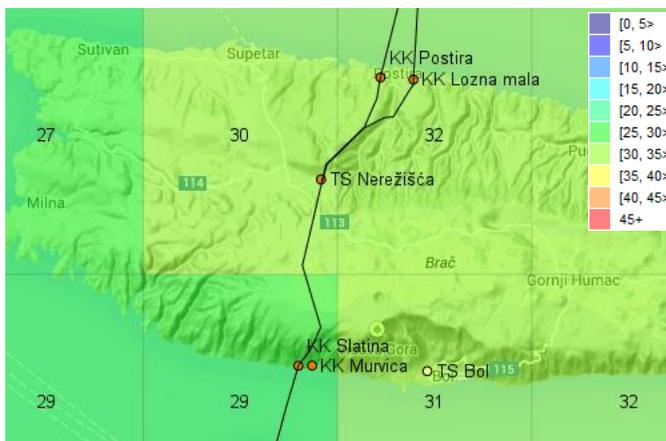
Fig. 4 shows that the LLS measured up to 32 lightning days per year for the area surrounding the observed overhead lines. The time period of six years might be insufficient to obtain the credible statistics. By comparing these values with the ones from the previous year [3], it is possible to see how much statistics could be influenced by the climatologically extreme year.

Fig. 4. Keraunic map (lightning days per year) of the observed area (2009-2014)

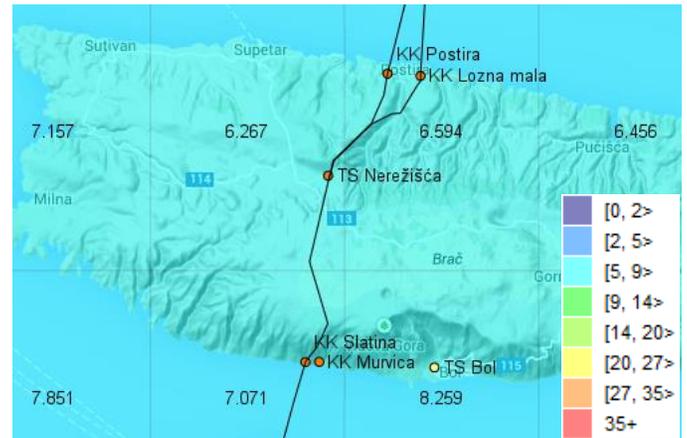
Fig. 5 shows the map of cloud to ground stroke density for the observed area. The ground stroke density varies between 6.59 – 8.26 strokes/km²/year. The majority of lightning flashes comprise multiple strokes which occur a few milliseconds of each other. According to the LLS data, the observed area had an average stroke multiplicity of 1.58 strokes per flash. The values on the map shown in Fig. 5 correspond to the values of 4.17 – 5.23 flashes/km²/year.

Fig. 5. Ground stroke density [1/km2/year] map of the observed area (2009-2014)

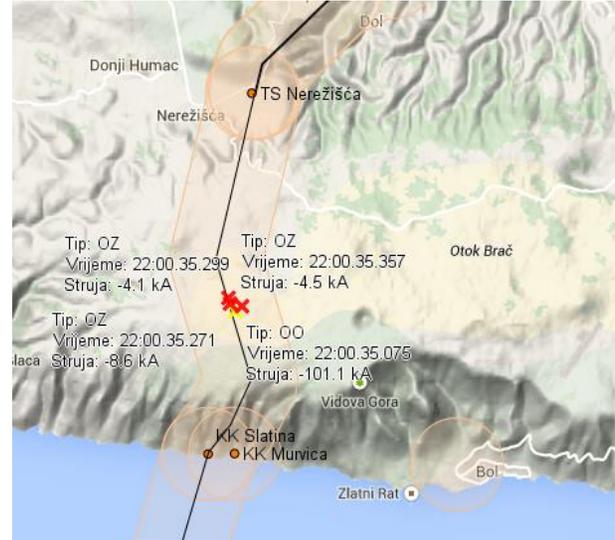
The relay protection system and corresponding LLS data for the Case 1 are given in the Table II, while the time- spatial correlation between relay protection system and LLS data are shown on the Fig. 6.

Fig. 6. Time and spatial correlation between relay protection system and LLS data, Case 1

According to the overhead line design documentation it was determined that the tower on the given distance between the substation and the lightning stroke location was tower number 17. Measured tower's footing resistance was 16 Ω .

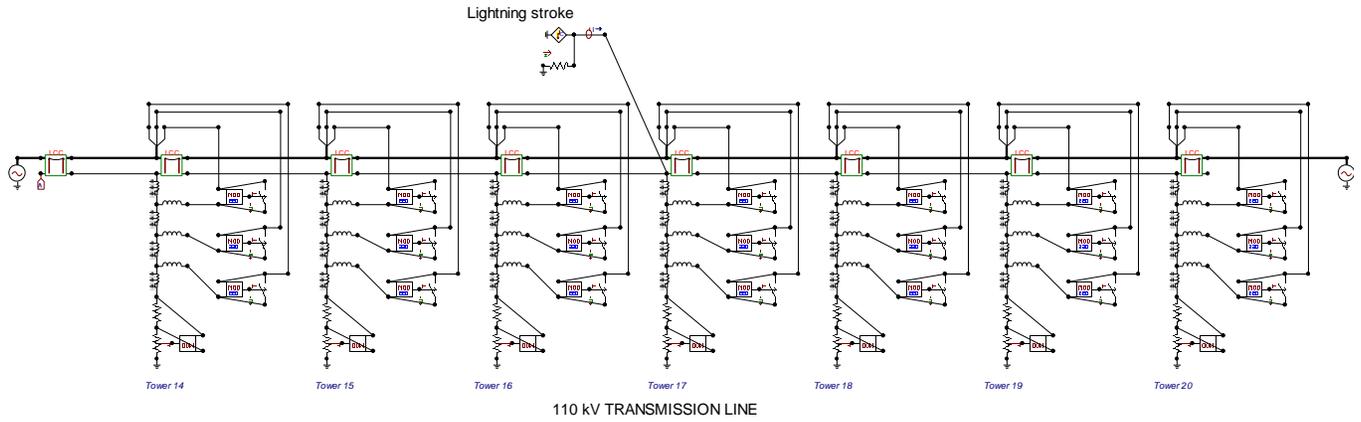
Fig. 7. Model of 110 kV transmission line in EMTP/ATP

The transmission line conductors and shield wire were represented by frequency-dependent model in EMTP/ATP. Three spans from both sides of a struck tower were taken into account. To avoid reflections of travelling waves, line is terminated with multiphase matching resistance at both ends.

The calculations of lightning overvoltages were carried out in case of lightning stroke to tower 17. For the simulations purposes, three spans from both sides of the struck tower were modelled in the EMTP software (Fig. 7). Lightning stroke with amplitude of 100 kA was simulated. Median values of front time $t_f=5.5 \mu s$, time to half $t_{1/2}=77.5 \mu s$ and maximum front steepness $S_m=24 kA/\mu s$ of the lightning current waveform were selected according to [8].

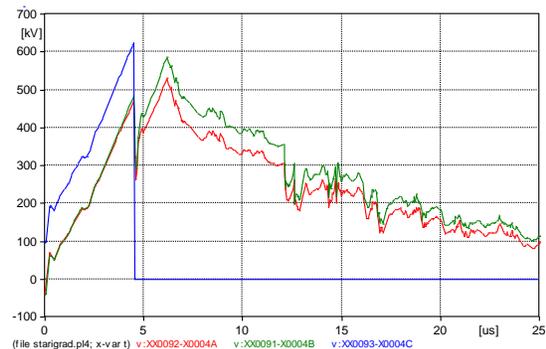
Fig. 8 shows calculated overvoltages on insulators of the struck tower. Back flashover occurs in bottom phase of the struck tower and adjacent towers as well.

Fig. 8. Overvoltages on insulators of the tower number 17 during back flashover at bottom phase C ($I_f = 100$ kA, $R_G = 11 \Omega$)

Power frequency voltage source was represented with a cosine function. It was assumed in the simulations that the lightning stroke occurred at instant of power frequency voltage peak in bottom phase (voltage angle 60° in phase A), since the potential difference across the insulator string is highest in this case.

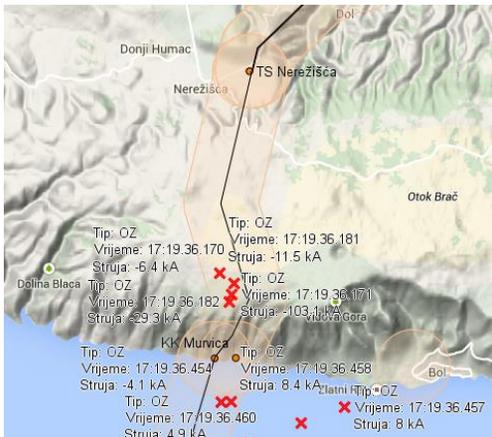
The relay protection system and corresponding LLS data for the Case 2 are given in the Table V and the time and spatial correlation between relay protection system and LLS data are shown in the Fig. 9.

Fig. 9. Time and spatial correlation between relay protection system and LLS data, Case 2

According to the overhead line design documentation it was determined that the tower on the given distance between the substation and the lightning stroke location was tower number 21. Measured tower's footing resistance was 7Ω .
