TUCURUI'S GENERATOR STEP-UP TRANSFORMER FAILURES DUE TO VERY-FAST TRANSIENTS IN GIS

J. F. de Lima F^o C. Machado Jr. W.S. Pinto
Centrais Elétricas do Norte do Brasil - ELETRONORTE
BR 70718-900 SCN Quadra 6 Conj. C Brasília DF-Brazil

J.C.Mendes R.A.Marcondes
ABB Asea Brown Boveri T&D
BR 07190-904 São Paulo , SP-Brazil

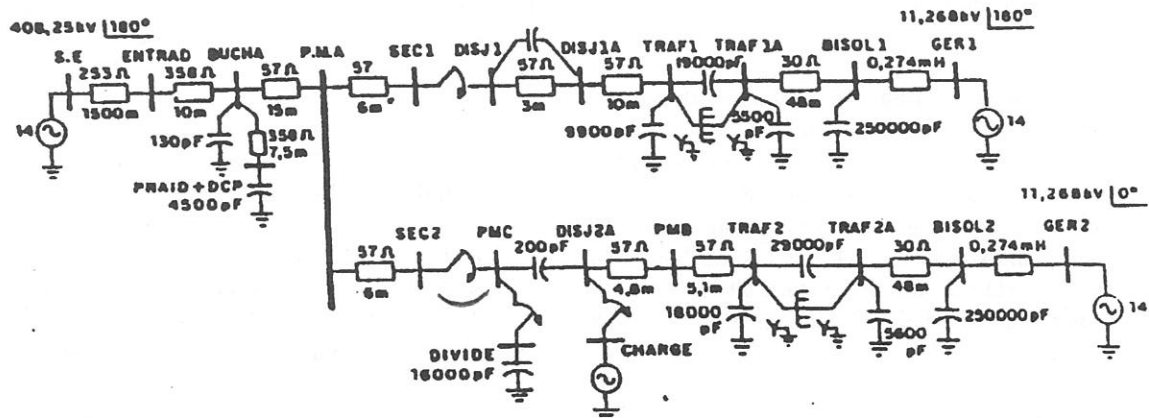
Figure 3 - Basic configuration modeling

In Fig. 3 the capacitor between nodes PMC and DISJ2A represents the grading capacitor between open contacts of the breaker and the simulations with opposite polarity were performed through generator voltage GER2.
